Casper Region

The focus of 2014 in the Casper Region can be summed up in one word: invasives. Whether it is soil invading the river, cheatgrass intruding on native habitats or invasive Russian olive trees along riparian areas, the Casper Region has tackled invasives in 2014.

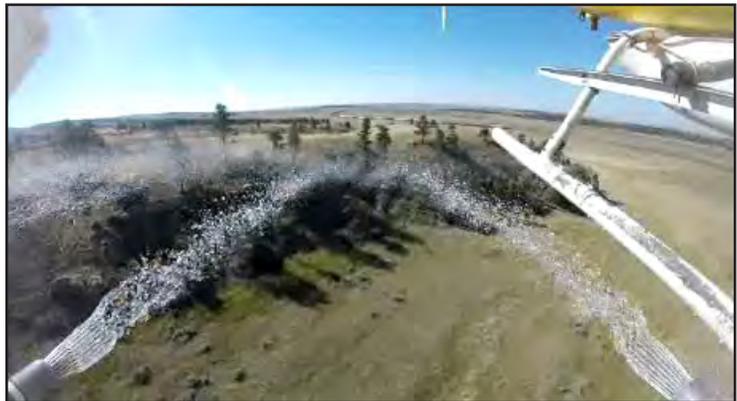
Figure 12. *Helicopter spraying imazipic herbicide on Elk Mountain.*

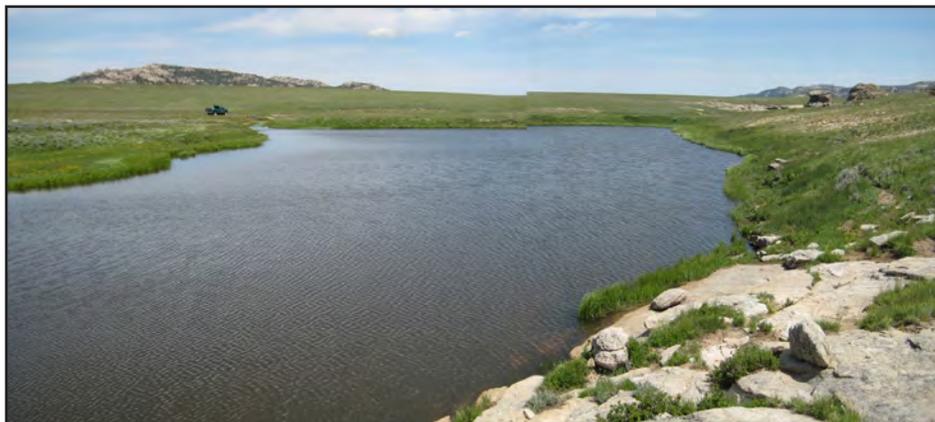
Figure 13. *Blue Downey Park Reservoir*

Blue Downey Park Reservoir (Figure 13) is a one-acre impoundment on North Fork LaBonte Creek. Historically, the reservoir's depth permitted brook trout populations to persist for decades. Many in Douglas use this and the neighboring ponds and streams for fishing with their families. An incision dropping about six feet threatens to drain the reservoir and completely blocks upstream fish movement (Figure 14). Unchecked, this incision could drain the reservoir and wetland. Initially, a rock chute and various channel treatments were proposed to stabilize the headcut but this approach proved expensive. In 2014, additional data were collected to more fully assess alternatives. Longitudinal profiles and bankfull estimates were measured in the channel downstream to evaluate how the proposed channel would respond to peak flows. Bathymetric reservoir mapping done in 2014 illustrated that volume had decreased 50-66% over the 60-year lifespan of the reservoir. Maximum depth now is only about 9 feet and Sago pondweed is abundant in the reservoir, with large quantities occurring in water between 2 and 6 feet deep.

Given the shallow nature of the pond and likely limited remaining life span of the reservoir, it will likely be prone to winter kill in the future. As a result, there is not a great deal of urgency in stabilizing the overflow channel unless significant dredging were to occur. These options begin to reach a cost level that an alternative approach - constructing a new reservoir downstream - begins to appear more economically viable. A new reservoir would provide a new long-term fishery, stabilize the previous reservoir dam, maintain the existing wetland, and control the headcut migration. This reservoir would allow erosive energy from the current reservoir spillway flows to be dissipated in the pool of the new downstream reservoir, while the new dam would meet current engineering specifications by using modern spillway designs and on-site materials.

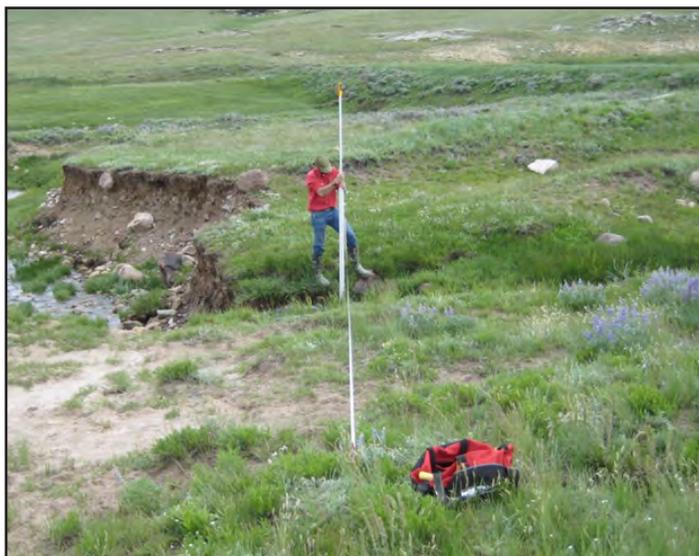
Figure 14. *The headcut threatening the reservoir.*

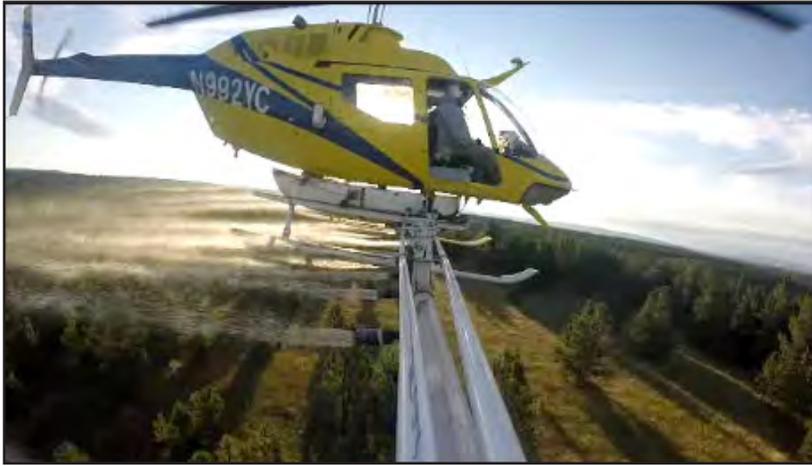
Figure 15. Helicopter spraying imazipic herbicide on a cheatgrass infested pasture in Oil Creek.

adjacent to the 2013 treatments (Figure 15). Funding for this project came from the participating private landowner, Weston County Weed and Pest (WCWP), Rocky Mountain Elk Foundation (RMEF), WWNRT, WGBGLC, and the WGFD Habitat Trust. Results from 2013 herbicide treatment were spotty, with some areas seeing 100% control of cheatgrass while others showed an increase in cheatgrass density. Although cheatgrass density in some plots was higher than pre-treatment levels, cheatgrass was small and stunted in nature, which provides evidence of exposure to herbicide. High autumn precipitation in fall 2013 and increased litter accumulations likely favored cheatgrass germination despite herbicide treatment in some of the treated areas. Monitoring will continue to assess control of cheatgrass within the Oil Creek treatments.

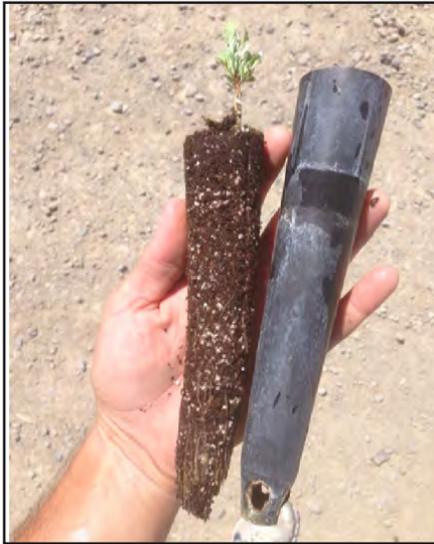
Figure 17. Sagebrush seedlings grown from native seed collected in the Douglas Sage-grouse Core Area.

This project is located in the Douglas Sage-Grouse Core Area and assists in promoting the long-term sustainability of sage-grouse as designated by the Governor's Sage-Grouse Core Area Protection Executive Order. Project components include planting 12,000 sagebrush seedlings, treating 1,250 acres of cheatgrass, and establishing a vegetative firebreak within a 10,000-acre wildfire area (5,000 acre project area) north of Douglas, WY. The objective of the project is to increase habitat value and maintain proper functioning of the system to benefit pronghorn, mule deer and sage-grouse. Local sagebrush seed was collected and grown in 10ci containers (Figure 17) and planted in an island approach in November 2014 (Figure 18). The goal of this planting is to provide a seed source for natural re-establishment of sagebrush. The objective of the cheatgrass treatment, which was completed in 2013, and vegetative fire break are to reduce recurrence of fire within the project area. Additionally, treating cheatgrass will reduce competition with native species that wildlife depend on for forage and cover.

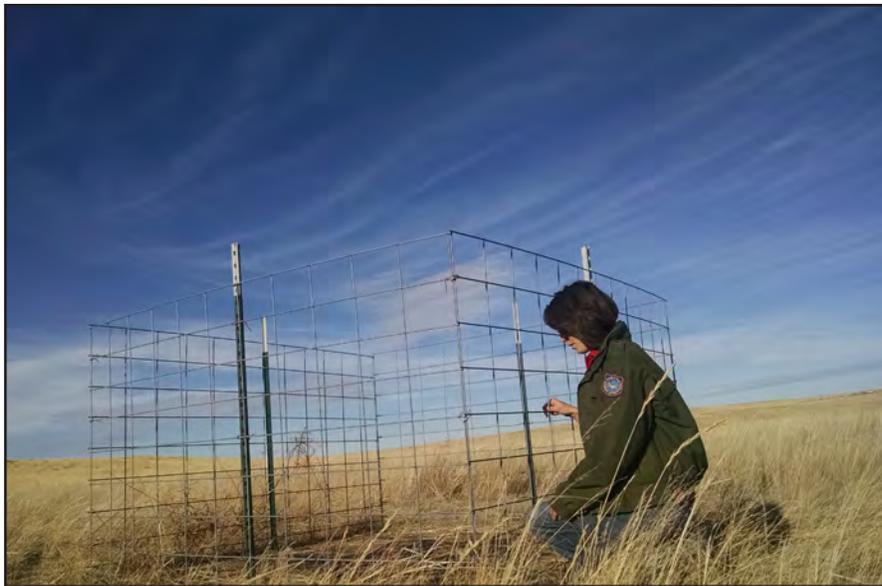
Figure 18. Sagebrush seedlings planted in exclosures in the Douglas Sage-Grouse Core Area.

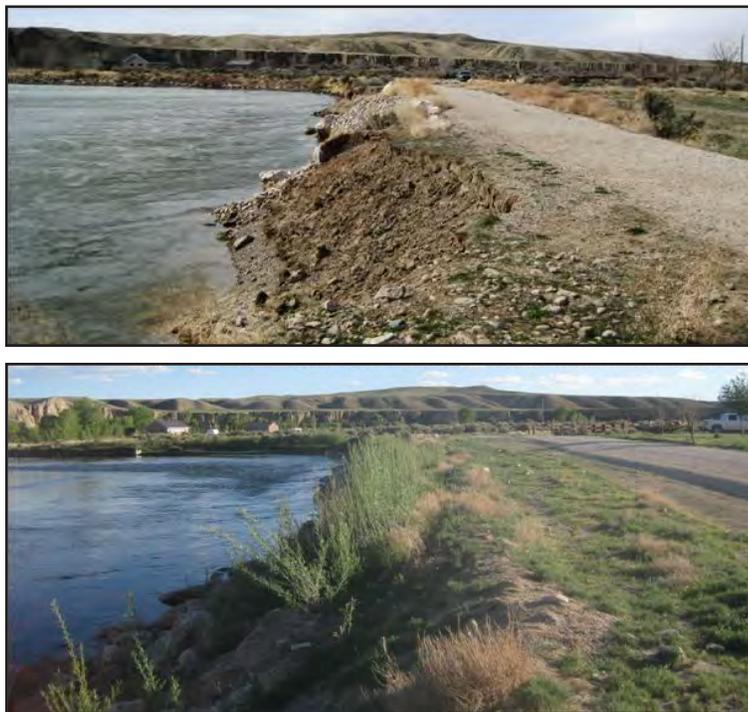
Figure 22. *Lusby Public Access Area bank before stabilization (above) and two years afterward (below).*

monitored for pre- and post-construction comparisons (Figure 22). A project was completed in May 2012 to stabilize 210 yards of streambank erosion threatening the access road along the North Platte River at Lusby PAA. In the spring and summer of 2011, a previous attempt (2010) to stabilize the streambank failed, taking with it another 15-20 feet of the stream bank and much of the armoring. In April 2012, a contractor placed 70 concrete “Lego-style” blocks in the North Platte River; topped with 350 yards of 36” bank riprap. Non-woven geotextile material sat below the riprap and shredded fiber landscaping fabric capped the riprap. Personnel planted this area with approximately 500-750 harvested coyote willow cuttings using a waterjet stinger. The landowner watered these almost daily using a WGFD provided drip system. The willows within the watering area saw survival upwards of 95%, while those outside the watering system saw survival levels

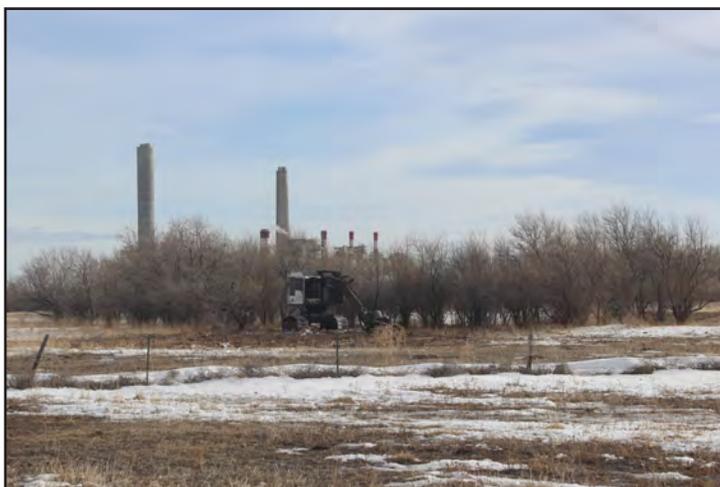
Figure 21. *Russian olive mastication at the Dave Johnston Walk-In Area.*

The project area is located on the Dave Johnston WGFD Walk-In Access area as well as on unenrolled adjoining PacifiCorp property along the North Platte River. The treatment area is comprised of 4.5 miles of riparian habitat along the North Platte River and consists of approximately 380 acres of Russian olive stands. Mechanical removal work commenced in winter of 2014 - 2015 via mastication and will be completed by March 2015 (Figure 21). Chemical re-treatment and maintenance will occur through 2018, with long-term maintenance occurring less frequently thereafter. Native woody species will be planted in 2016 and 2017 depending on the level of Russian olive control. This project aims to substantially reduce Russian olive abundance and seed dispersal along the North Platte River, thus increasing native species diversity, water availability, and habitat quality for wildlife.

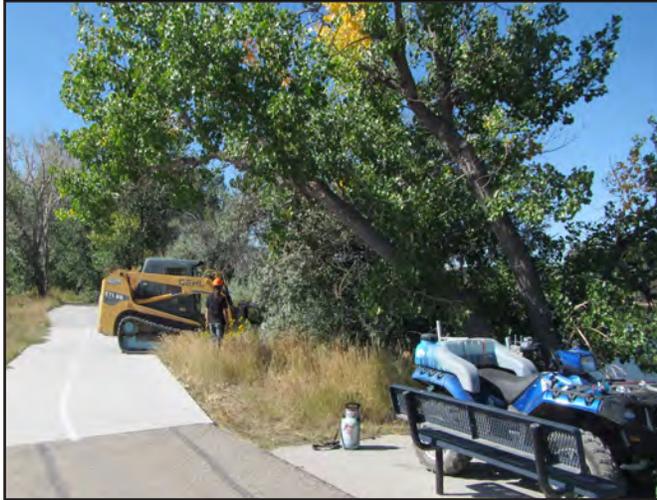
Figure 23. Pulling Russian olives with a skid-steer mounted brush grapple along the North Platte River.

Seven sites will receive in-river habitat treatments, while twelve sites will receive vegetative habitat restoration (Figure 23). These sites were selected based on ecological and political parameters. The restoration of the North Platte River will improve physical, chemical and biological components of the river and downstream waters as well as produce economic and social benefits. Construction of the first two sites is planned for 2015. Russian olive removal began on the Morad Park site in September 2014, preceding river restoration construction in 2015 (Figure 24).

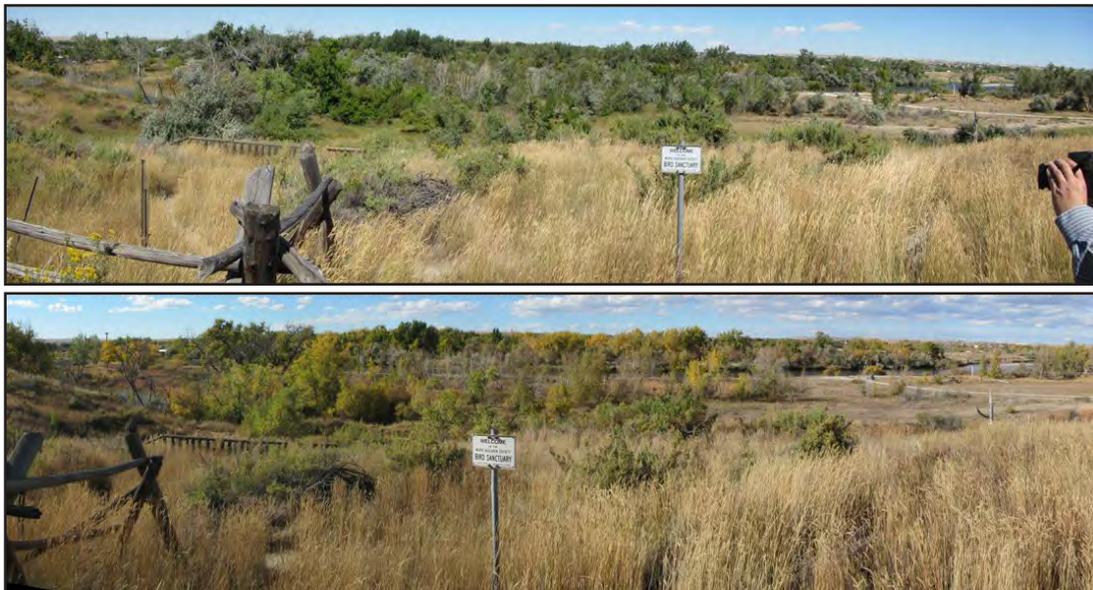
Figure 24. Morad Park prior to (above) and following (below) Russian olive removal in September 2014.

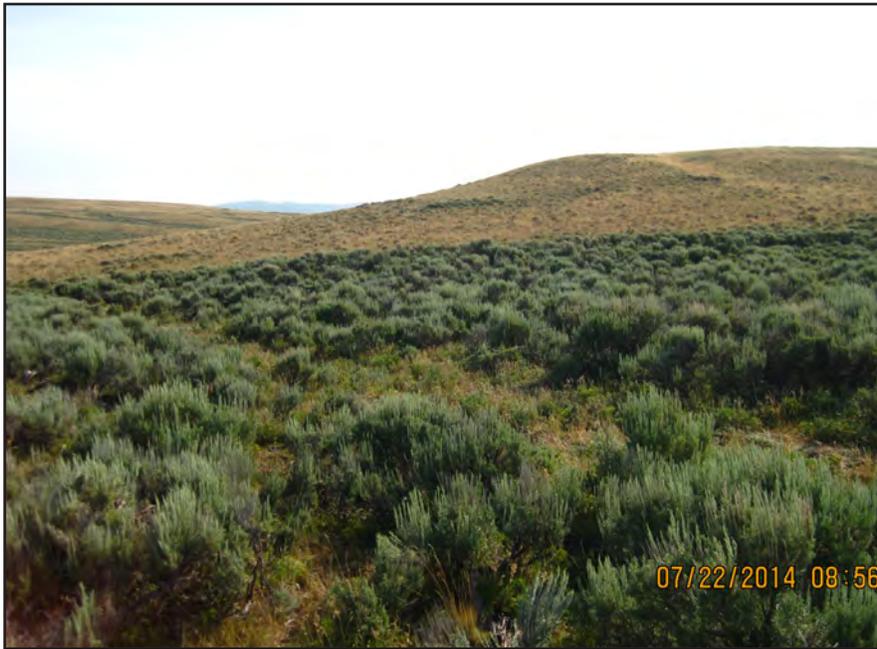
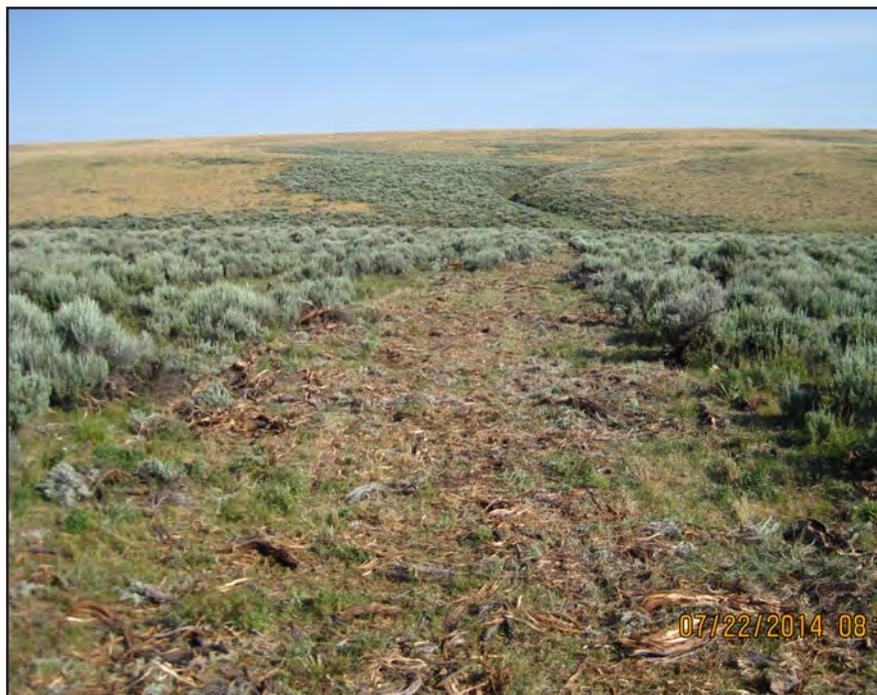
Figure 25. *Snow accumulation area with big sagebrush thinning.*

Figure 26. *Snow accumulation area with big sagebrush thinning.*

big sagebrush canopy cover. Therefore, we proposed to mechanically treat these areas with a rubber-tracked skid steer and brush hog mower (Figure 25 and Figure 26). The treatment is designed in such a way that it is not considered a disturbance within the sage grouse core area executive order, and the benefits to sage grouse and other wildlife will be increased grass production, increased forb production, improved hydrologic function and increased plant community diversity. As of December 2014, three acres were mowed out of the 140 acres proposed. The small acreage figure is the result of the skid steer being too small (underpowered) and the brush hog mower not being capable of dispensing mowed material in an efficient manner. As a result, the largest skid steer built was rented and will be used with a Fecon mulching attachment to implement the treatment moving forward.

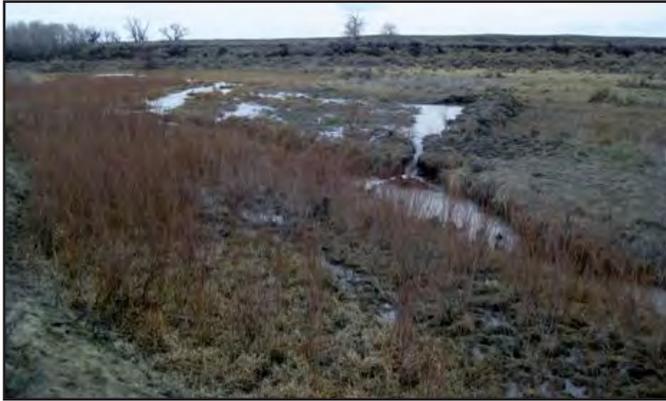
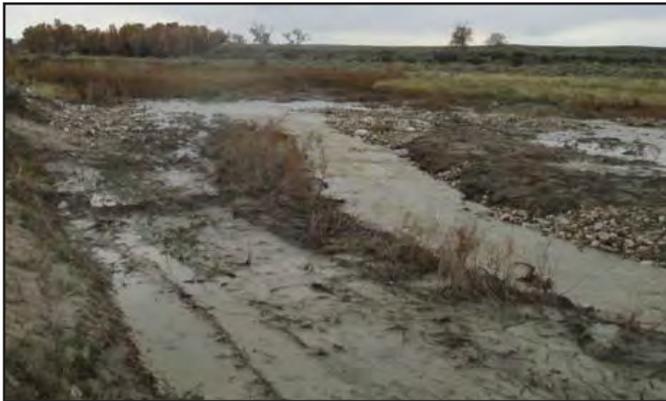
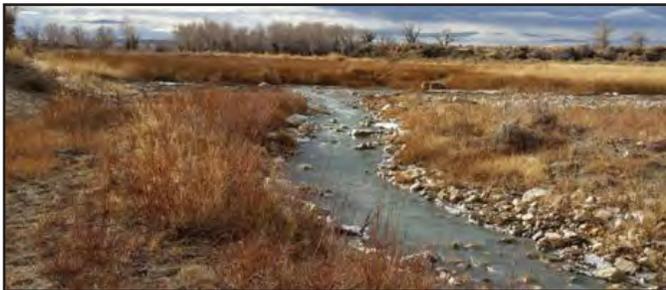
Figure 28. *Stinking Creek prior to piling installation (top), immediately following installation (middle), and one year post-installation (bottom).*

encourage the development of native riparian plant communities. The benefiting riparian species will stabilize the channel, limit sediment transport, and encourage beaver activity. Additionally, several of the structures installed were intended to stabilize damaged reaches of the creek (Figure 28).

Sheet pilings were driven into the substrate, and a rock chute was used to dissipate the creek's energy. Geotextile fabric placed under the rock reduced contraction scour in these sandy soils. Vegetative and elevation data were collected at the four 2013 sites prior to installation, and photographic monitoring was used until the cameras failed. Efforts to control side channel headcutting occupied large portions of the spring field season. These efforts included transplanting willows in the form of buried waddles, silt fences, and vertical bundles (Figure 27). During the summer of 2014, longitudinal profiles were collected at three of the 2013 sites. It was necessary to rework some of the structures due to damage sustained in high flow events and a backhoe was used to realign or bolster rock chutes at several sites. This machine was also used to pull on-site Russian olives.

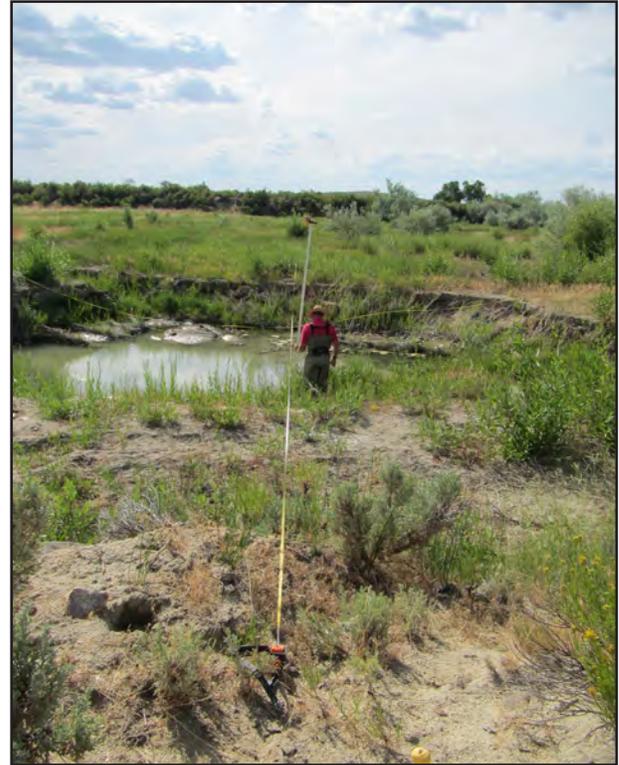
Figure 27. *Vertical bundles used to stabilize creek banks can be seen growing along the far bank less than four months after they were planted.*

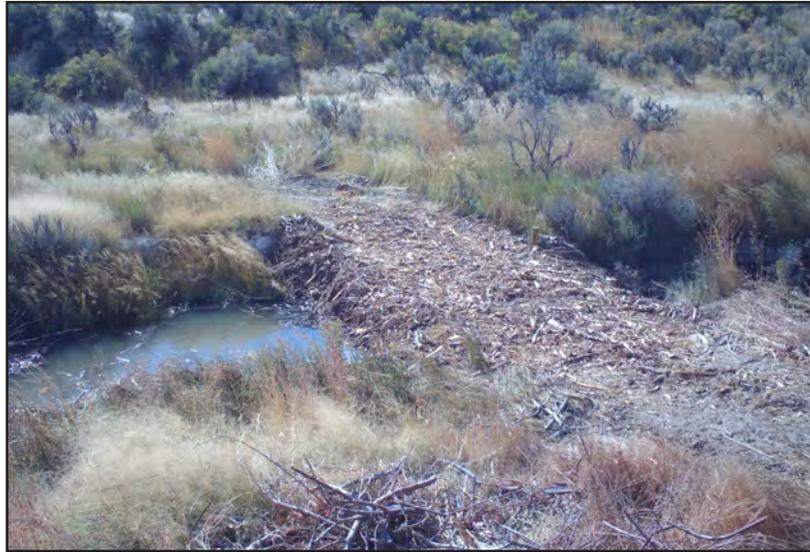
Figure 29. *Insta-dam installation on Bolton Creek.*

In 2014 the WGFD hauled 152,720 pounds of shredded tree material and 38,180 pounds of tree branches and limbs for a total of 190,900 pounds. All of the tree branches and limbs were used to create 12 “insta-dams” in Bolton Creek. The “insta-dam” is designed to mimic a beaver dam, which will trap sediment, raise the water table, dissipate energy following precipitation runoff events, and slowly release water during low flow times of year (Figure 29 and Figure 30). In addition to the tree branches and limbs, WGFD personnel placed 73,040 pounds of shredded tree material onto the “insta-dams” to further improve their design. The remaining 79,680 pounds of shredded tree material was placed into a gully to slow the movement of an active headcut, which we estimate is approximately 20 feet deep, 15 feet wide, and 20 feet long (Figure 31). Following installation of the “insta-dams”, we live-trapped 2 beaver from Casper and relocated them into the section of Bolton Creek where the “insta-dams” are located. As of November 2014, the beaver have modified 5 of the “insta-dams” and created 3 new dams in close proximity. All of this work was conducted in-house utilizing rented equipment that consisted of a mini-excavator, skid steer, dump trailer and rubber-tracked dump truck.

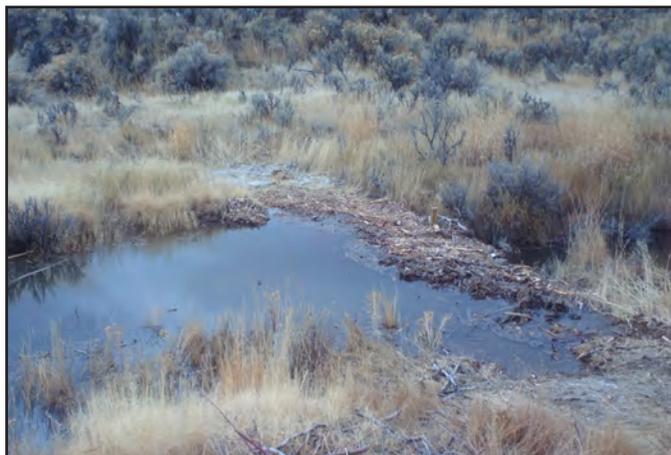
Figure 30. *Insta-dam modification by beaver.*

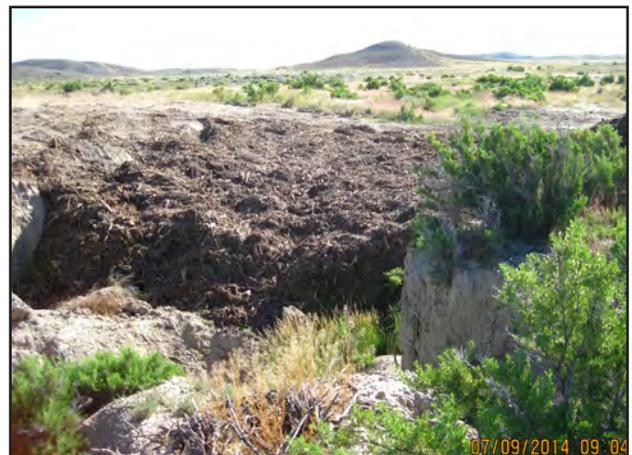
Figure 31. *Shredded tree material placement in active headcut.*

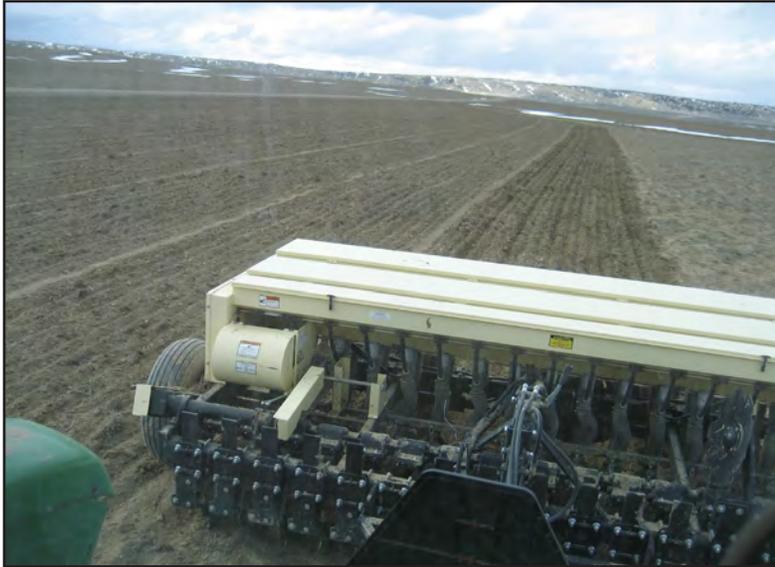
Figure 32. *Drilling seed on 50-mile flat.*

The project involved drill seeding native grass, forb, and shrub seed mixture on 250 acres of BLM land with a no-till rangeland seeder to rehabilitate important pronghorn and sage grouse habitats. The project took a bit longer than anticipated due to frequent precipitation, but the moisture aided in successful germination of the seed. Additional acreage may be seeded depending upon additional BLM funding. The BLM provided fuel and labor for the project. WGFD provided machinery, seed and labor.
